Vale's Vargem Grande iron ore conveyor lagging problem

Vale-operated Vargem Grande mine site is located in the state of Minas Gerais, Brazil and contains 2.53 billion tonnes of proven and probable iron ore reserves, making it the world's fourth biggest iron ore mining operation. The Vargem Grande site comprises three open-pits: Tamandua, Capitaó do Mato and Aboboras.

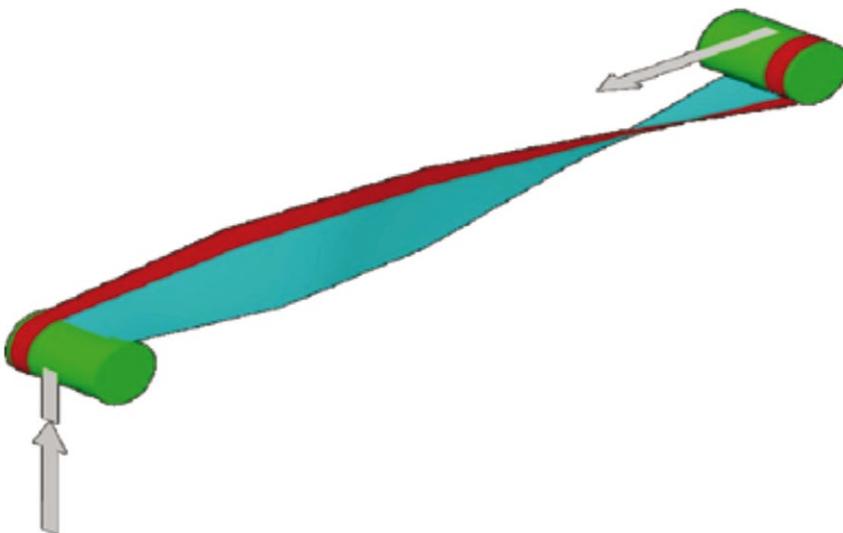
FIG #1

The Vargem Grande site maintenance personnel wanted to increase the service life of the lagging on a number of non-drive pulleys installed on a belt turn over conveyor. See FIG #1.

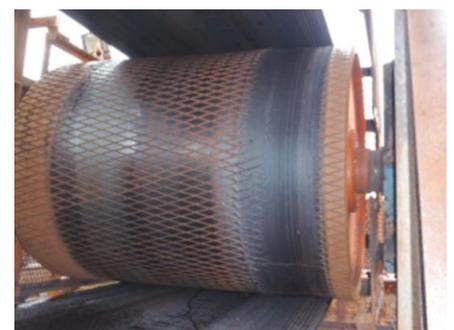
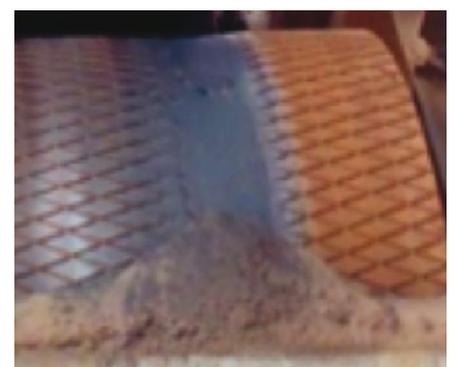
Severe localised belt wear was evident in as little as three months and the cost of conveyor downtime to replace the worn lagging was a serious problem. See FIG #2 & #3 below.

Vale were looking for a lagging solution that would extend the service life past that of the rubber lagging and that wouldn't cause wear on the conveyor belt covers. The Elastotec Polyurethane (PU) lagging was evaluated and considered a possible solution to this problem.

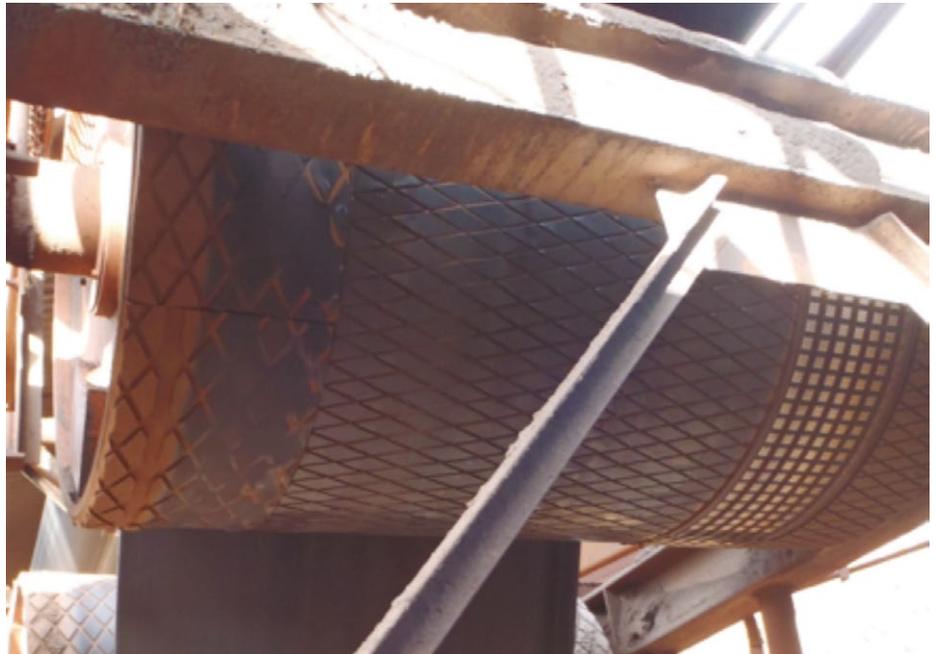
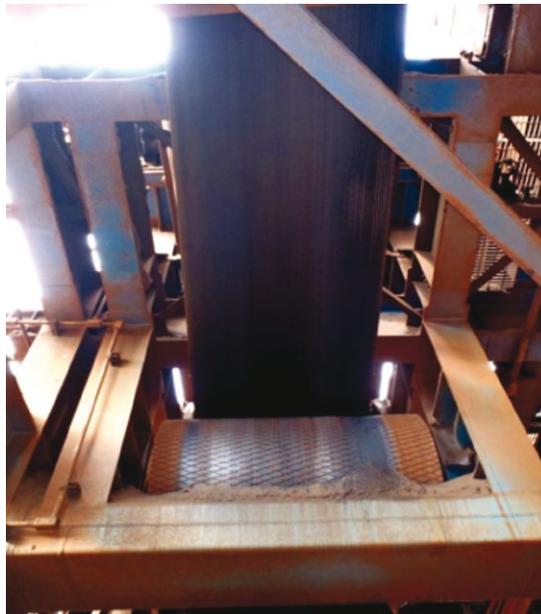
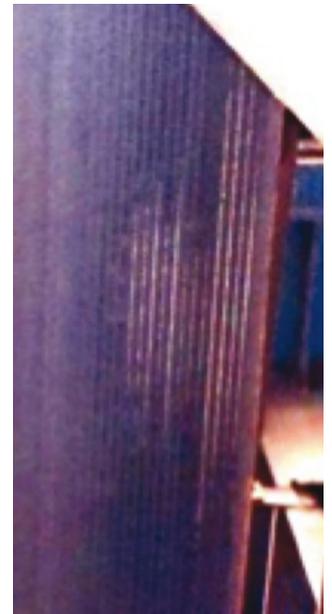
FIG #4

Initial attempts to address this problem by installing ceramic lagging in the high-wear areas fixed the lagging wear but transferred the high wear to the bottom belt cover. The steel cord ST3500 belt is a far more expensive component than the pulley lagging so the use of ceramic lagging was not a viable option. See FIG #4, #5 & #6.

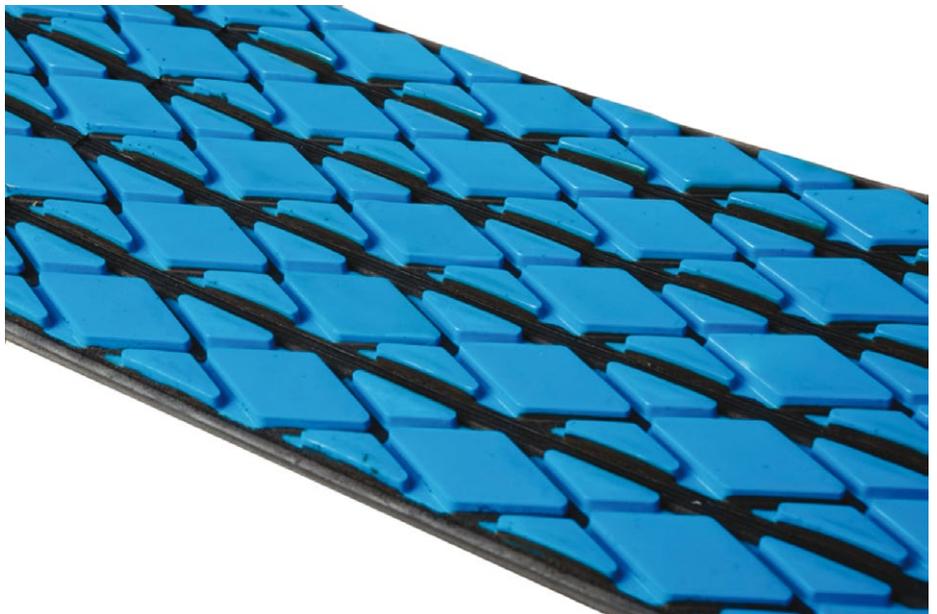
FIG #7

A decision was made to trial the PU lagging on two non-drive pulleys, each having a diameter of 1250mm and a face width of 1600mm. Elastotec supplied 12mm diamond PU lagging in strips to suit the pulley face width. The PU lagging can also be supplied in rolls up to 85 metres long, but in this case strips were preferred. See FIG #7.

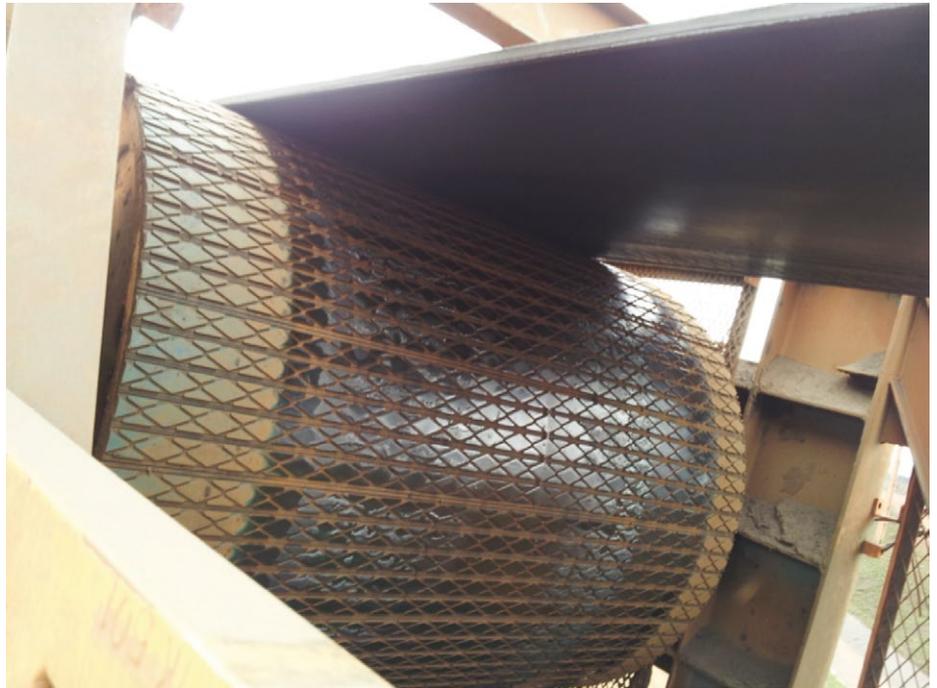
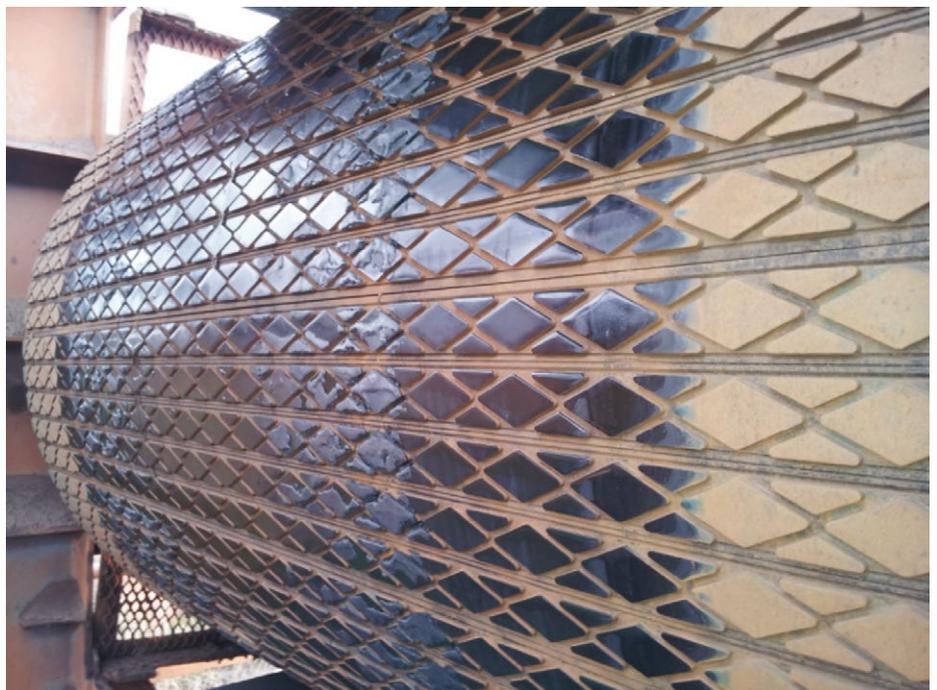
Elastotec supplied the PU lagging for both pulleys in December 2014. The lagging was manufactured with the Elastotec buffed CN bonding layer for cold vulcanised application. Metso applied the PU lagging onto the pulleys and in April 2015 the two pulleys were put into service. See FIG #8 & #9.

As of November 2019 these pulleys are still operating and show very little sign of wear. The PU lagging provided a service life increase of more than four years greater than the previous rubber lagging.

An additional benefit to the longer service life provided by the PU lagging has been the effect on the bottom cover of the steel cord belt where no additional wear has been observed. Given the high cost of steel cord belts this is possibly a greater cost saving than the extended life of the lagging.
