IRON ORE PORT FACILITY HIGH TENSION BEND PULLEY – ELASTOTEC POLYURETHANE LAGGING

Major iron ore port loading facility in the Pilbara Western Australia

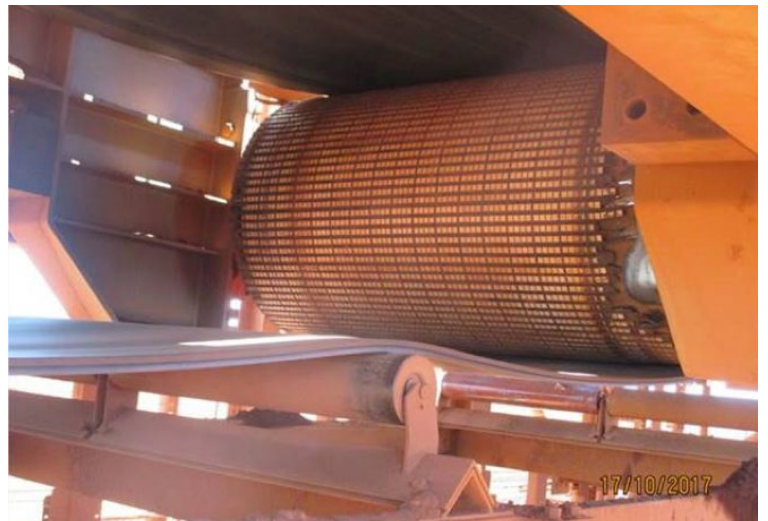
In November 2017 a major iron ore port facility in the Pilbara decided to replace the ceramic lagging on a high tension bend pulley – the ceramic lagging had suffered physical damage on one edge that had exposed the pulley shell (Photo#1). With a capacity of around 180 million tonnes/ annum of iron ore the port operates 24/7 year round and so reliability of the conveyor system is critical to achieving the maximum ore through put.

Photo #1: Ceramic lagging with physical damage along one edge

In December 2017 during a planned shut the damaged ceramic lagging was removed and replaced with the Elastotec 20 mm Plain Polyurethane lagging (see photos 2 & 3). The lagging on this pulley has been operating trouble free since December 2017. Elastotec believe that rubber backed Polyurethane lagging can successfully be used as an alternative to hot cast Polyurethane, providing comparable service life and with the added advantage of being suitable for on conveyor replacement of damaged or worn lagging. Hot vulcanised application of the Elastotec PU Lagging is always preferred as it ensures 100% rubber tear bonding and no joints, however like hot cast PU lagging the pulley must be removed from the conveyor for this type of application.

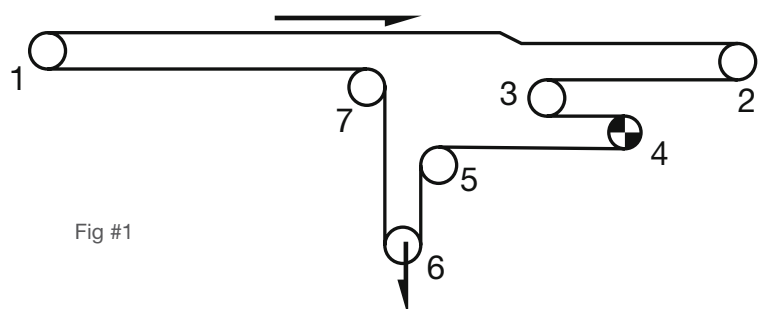
Fig #1

At the time hot cast polyurethane lagging was specified for all non drive pulleys by the port operator. The lagging specification had recently been revised to nominate polyurethane lagging in place of the previously used Direct Bond Ceramic Lagging (DBCL) because of its ability to resist build up. Build up from carry back has been a problem on ceramic lagged non drive pulleys in the Pilbara, and has caused belt tracking problems, and damage to belt and belt splices. This high tension bend pulley is the #3 pulley in Fig#1 below.
